# **Behavior of Contraction Joints in the Rehabilitated AASHO Test Road**

**Physical Research Report No. 75**

**Illinois Department of Transportation  
Bureau of Materials & Physical Research**

Interim Report  
IHR-28

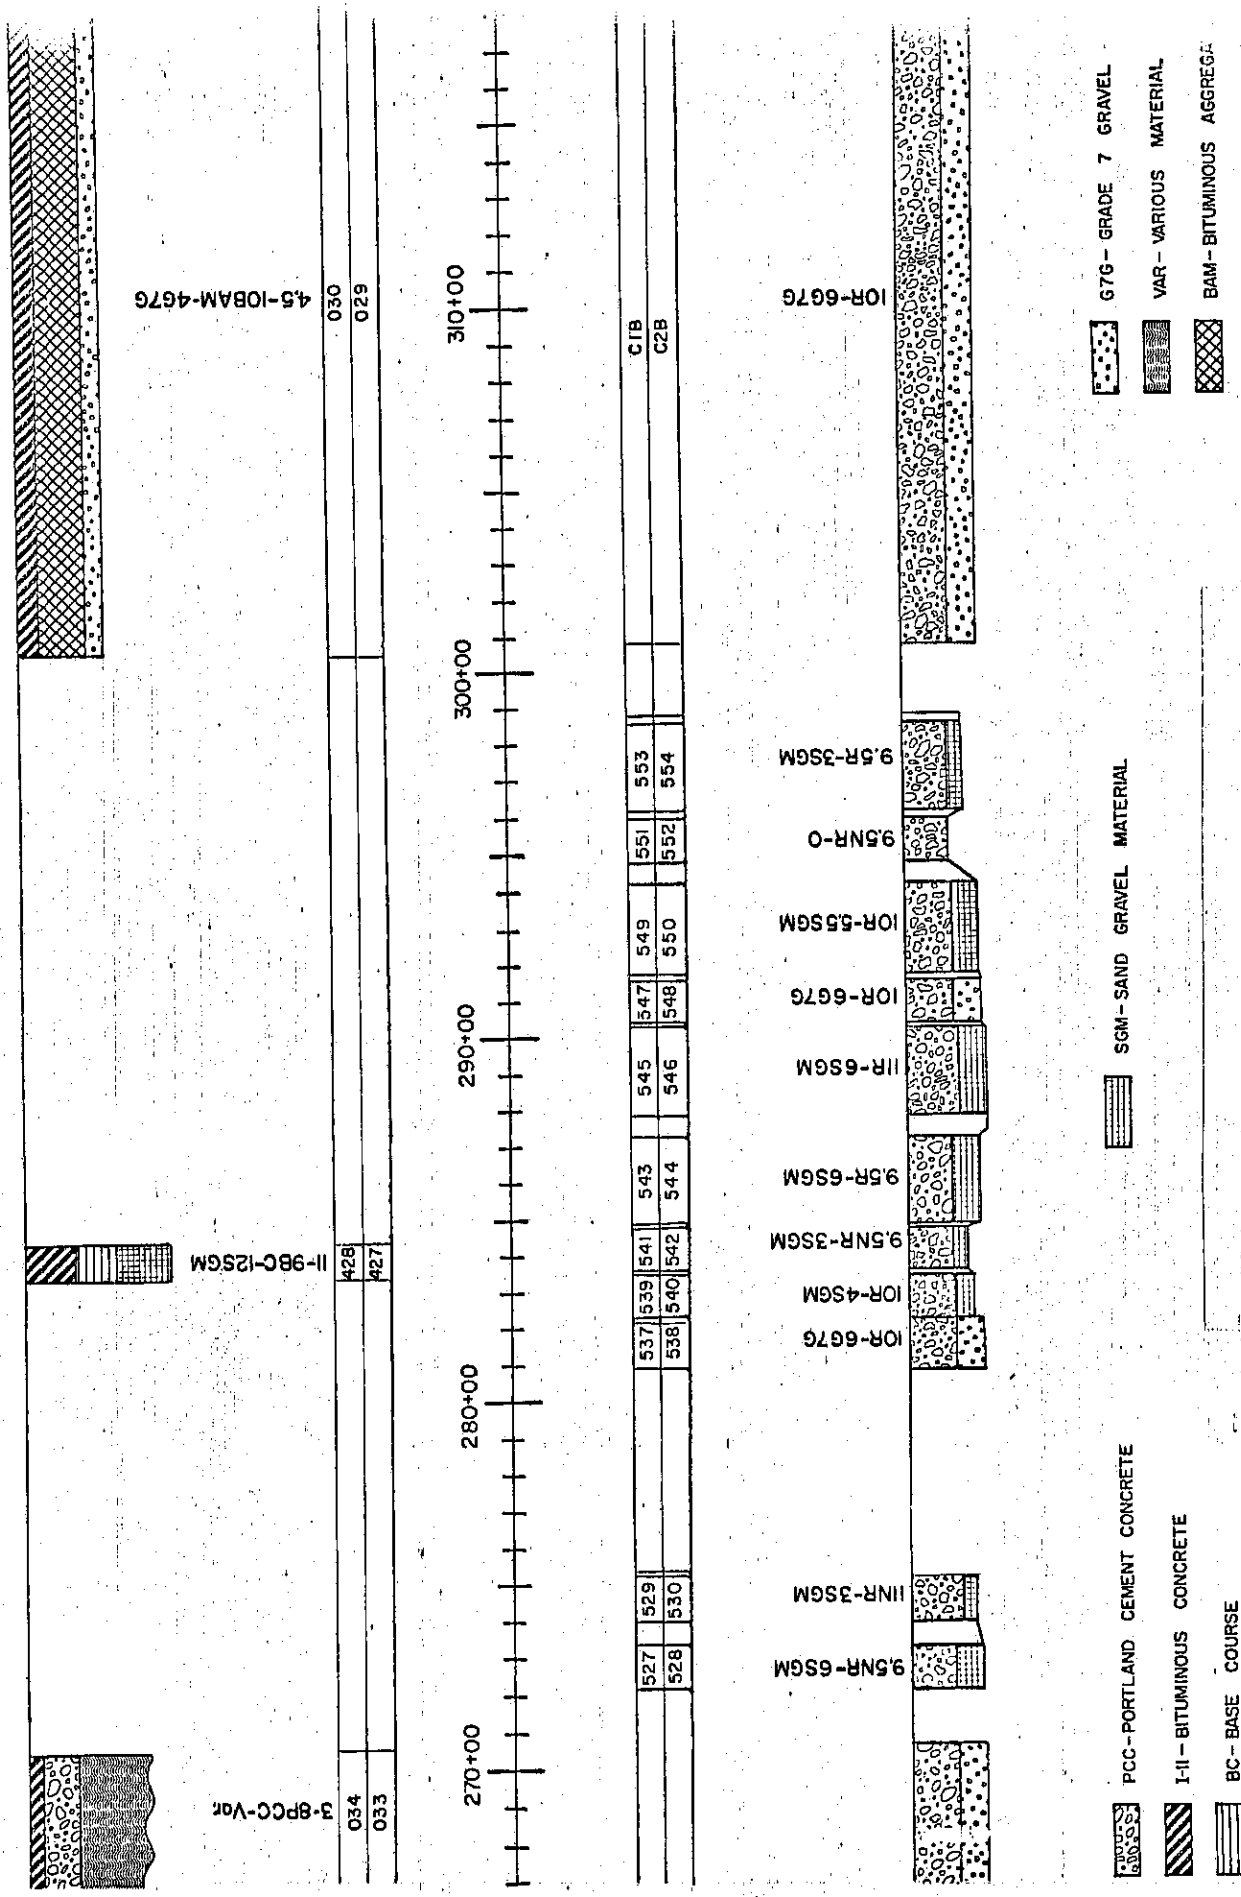
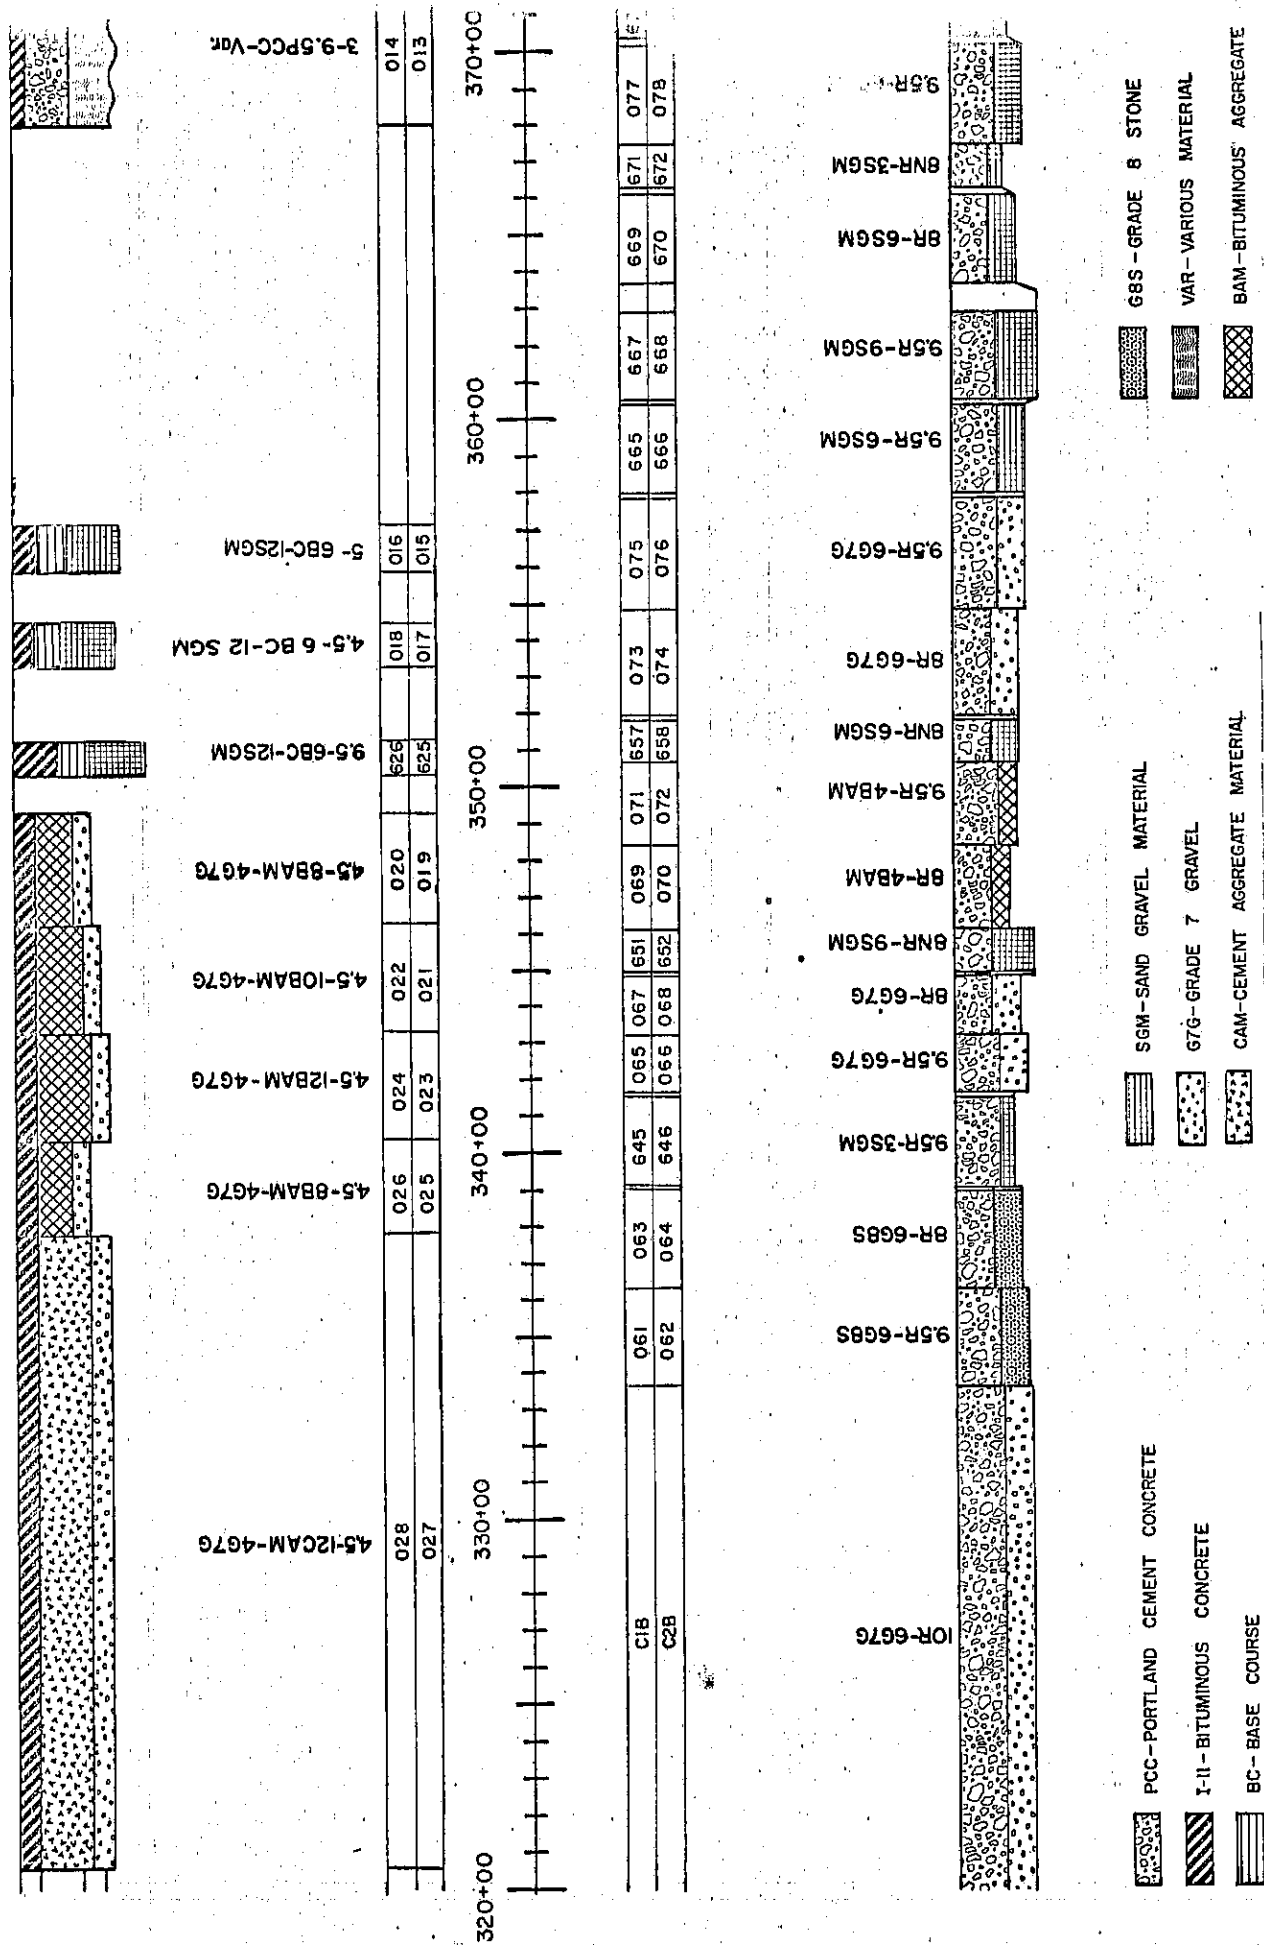
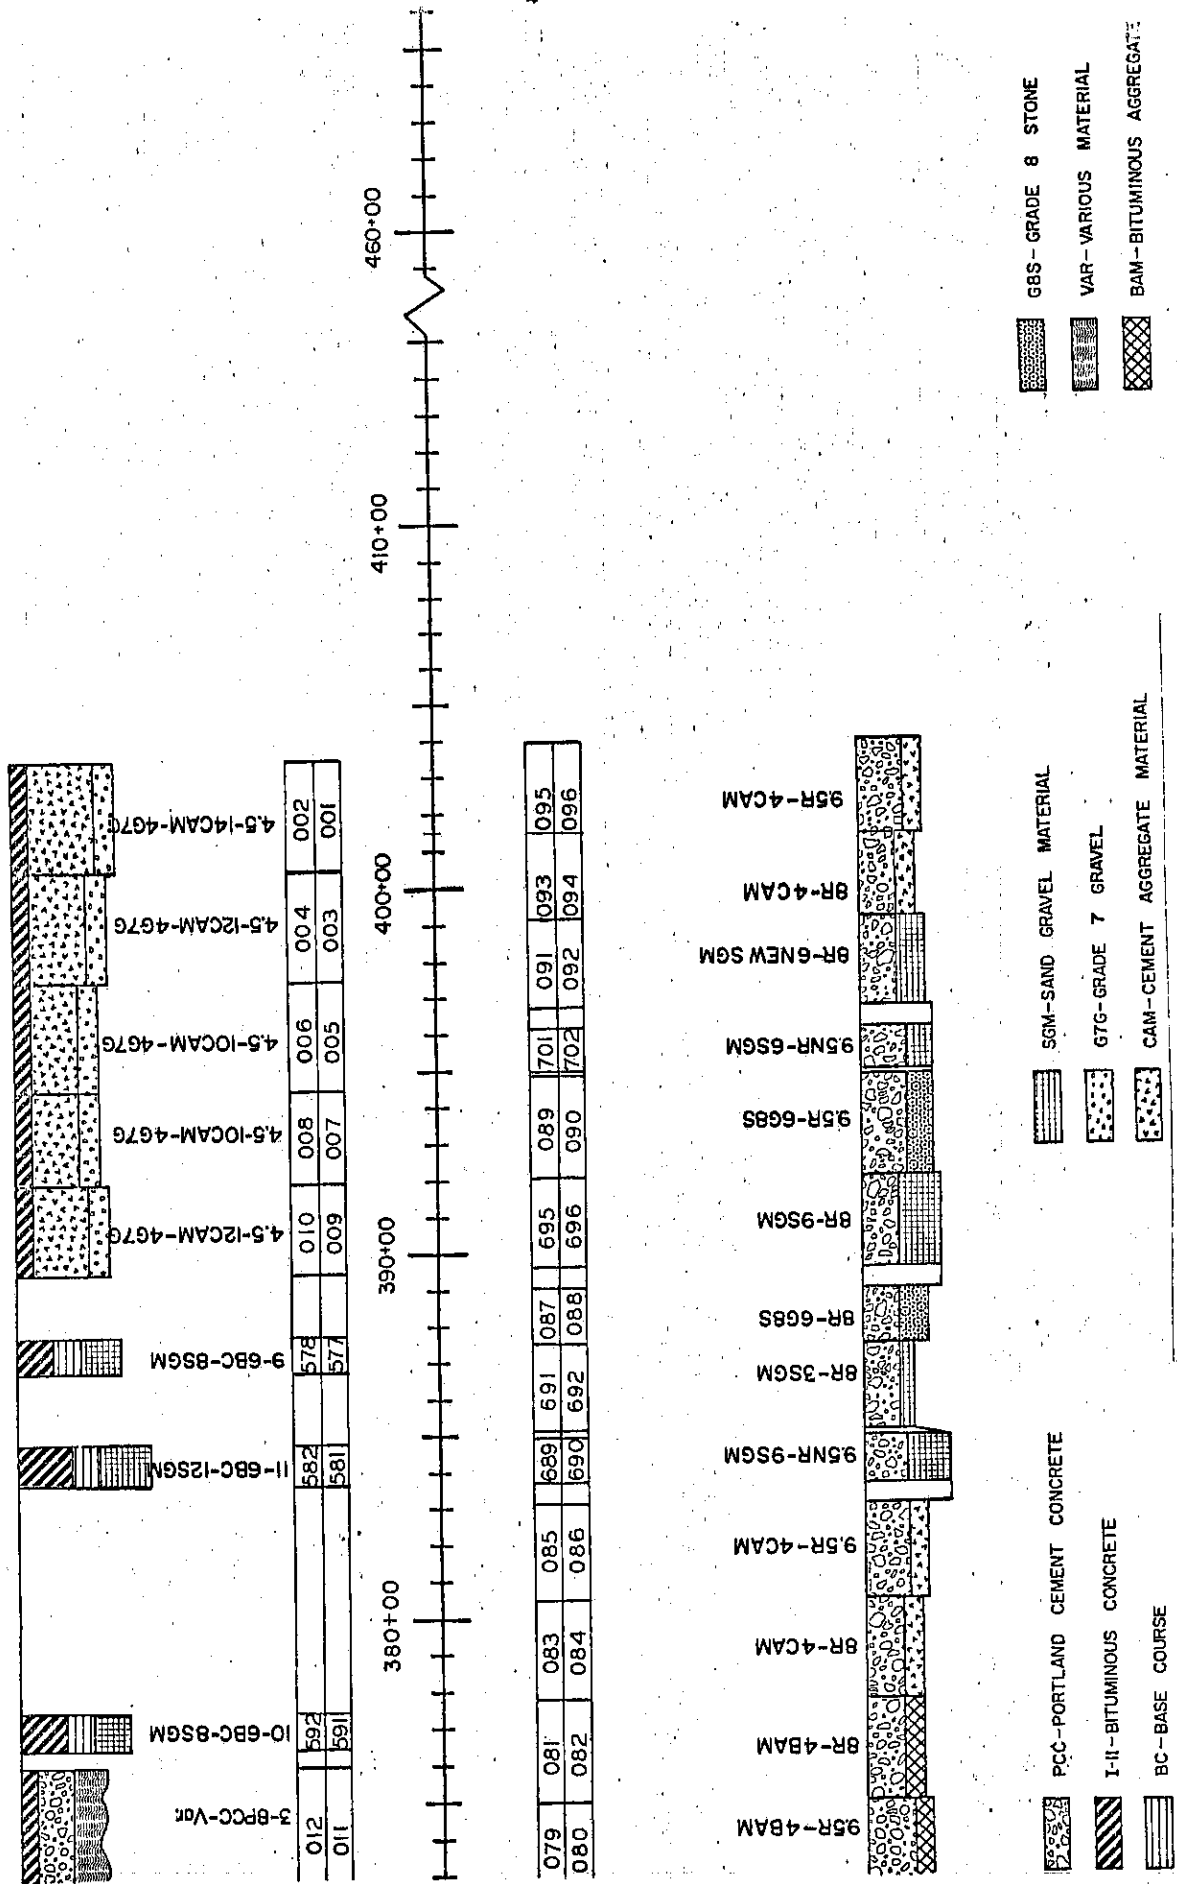
Figure A-1. Layout of test sections.  
(continued)

VAR - VARIOUS MATERIAL  
 G7G - GRADE 7 GRAVEL  
 G8S - GRADE 8 STONE
